Little Indian Lake: Diagnostic Study

Worcester Polytechnic Institute
Interactive Qualifying Project

By: Evan Costa, Victoria Mason, and Christian Waller

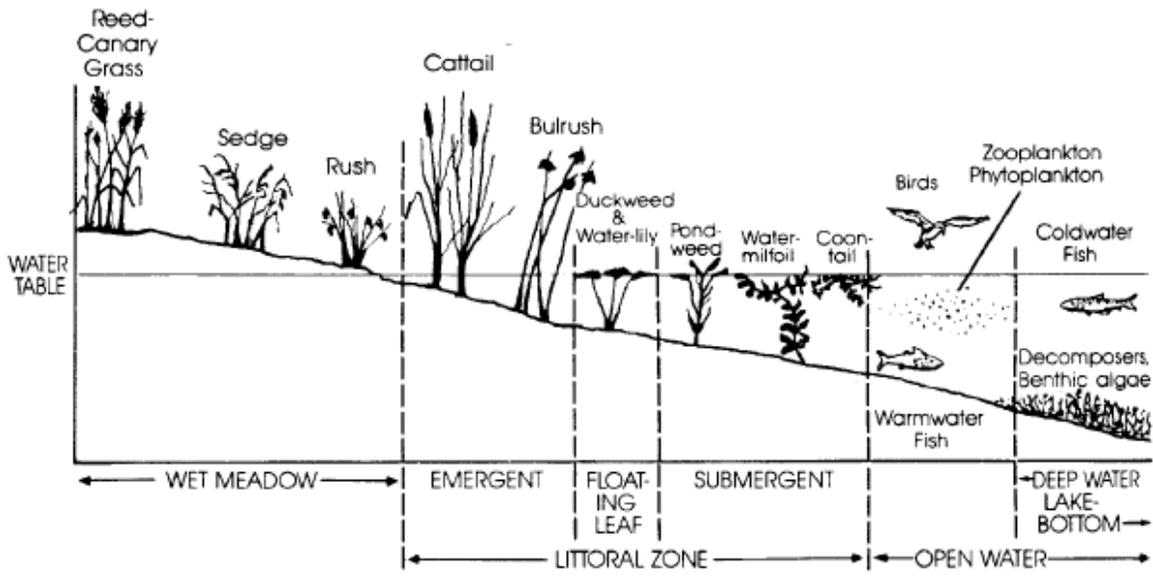
Lakes have distinct zones of biological communities linked to their physical structures (National Science Foundation, 2004). Figure 2.1 displays the specified areas of plant growth that can be observed in lakes and ponds: wet meadow, littoral, and open water or limonitic zones. The littoral zone is dependent upon the elevation of the lake bottom. The Minnesota Department of Natural Resources (2009) states that if there is a steep slope the littoral zone can be narrow and extend several feet from the shoreline. If instead the lake is shallow and the bottom slopes gradually, the littoral zone may extend hundreds of feet into the lake or may even cover it entirely. All three plant types described above (submerged, floating leafed, and emergent) can be found in this zone because of their proximity to the shoreline where sunlight exposure is at a

Figure 2.1: Typical Aquatic Plant Zones in Lakes and Pond (Wagner, 2004)

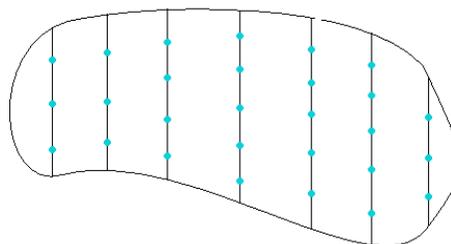
A series of planned observation sites were designated on the map prior to entering the lake and a record of which species (or type) of plants occur most commonly within the lake were also kept. Poles were on placed on opposite sides of the lake and fishing line was used to connect them; there were seven transverses made

Figure 3.1: Little Indian Lake divided into individual sections by transverses (data collection points shown).

spanning the horizontal length of the lake, line one was closest to MA-122A towards the most north end of the lake, where as line seven was located at the most southern point of the lake towards Forest Street. Various transects were created by tying orange fluorescent road tape and sectioning points along the line. In total thirty-seven sites were marked at fairly uniform intervals throughout the lake, which accounted for both shallow and deeper plant beds to get a representative sampling. During the course of the shoreline survey, stops were made at each of these sites and observations were recorded on the “Aquatic Macrophyte Observation Tally Sheet” (see Figure 3.3) to identify the species (or type) located at that site. The frequency of occurrence for each plant species was also calculated for each site.

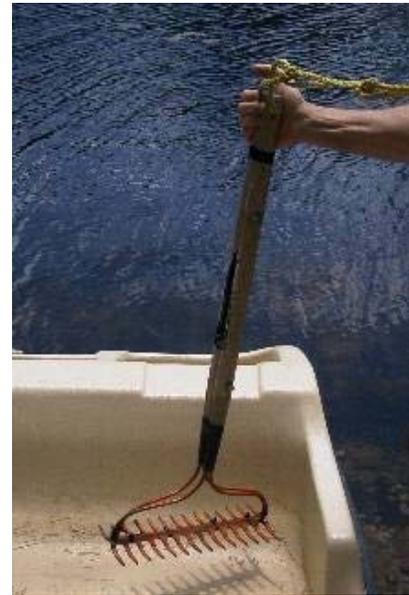
weasel at different angles around that point for 90°, 180°, 270°, and 360°. A weed weasel is a home-made contraption in which rope is attached to the end of a rake, and was utilized to collect samples from the bottom of the lake floor (Fig. 3.2). When collecting, the weed weasel was allowed to settle to the lake bottom and the line was then pulled up so that the teeth of the rake dragged along the bottom of the lake. The weed weasel was then raised out of the water with plant samples and brought into the boat. All the vegetation trapped on the teeth was put into separate piles, so that

*Figure 3.2: Weed Weasel
(Massachusetts Water Watch
Partnership, 2006)*

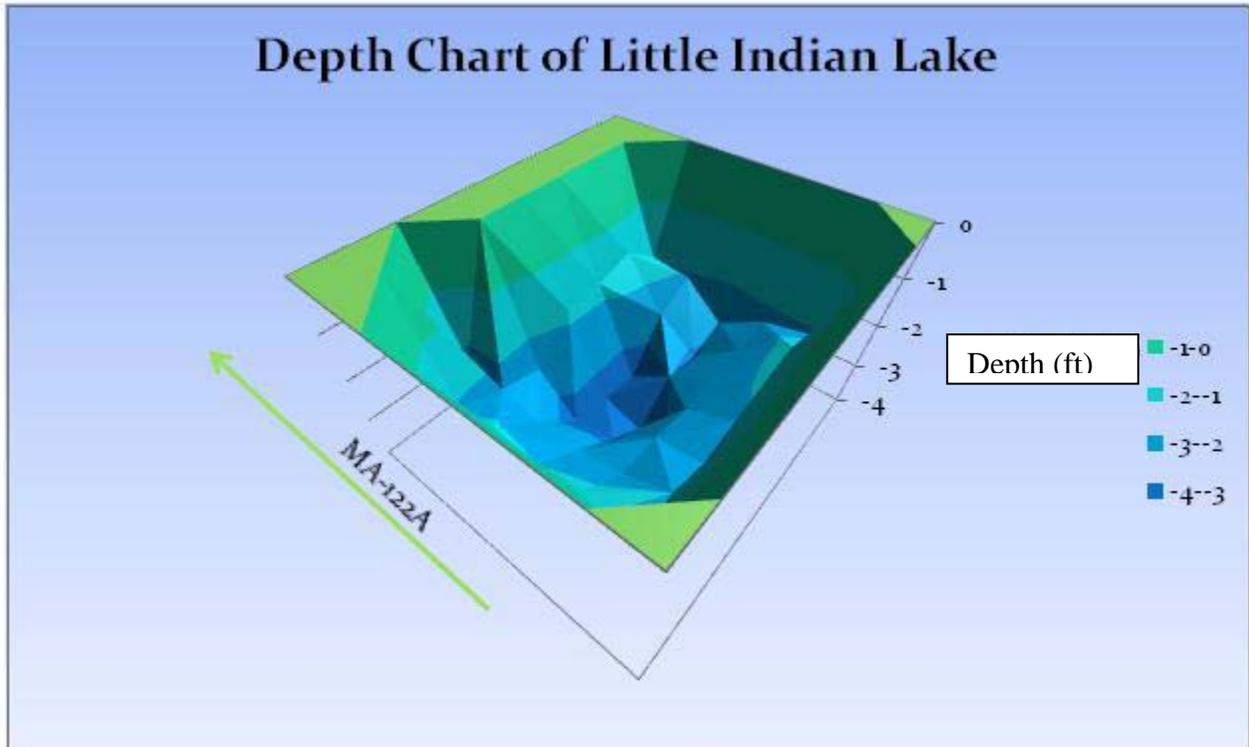
This data is presented in graphical form below in Figure 4.1.

Figure 4.2: Depth Graph of Little Indian Lake

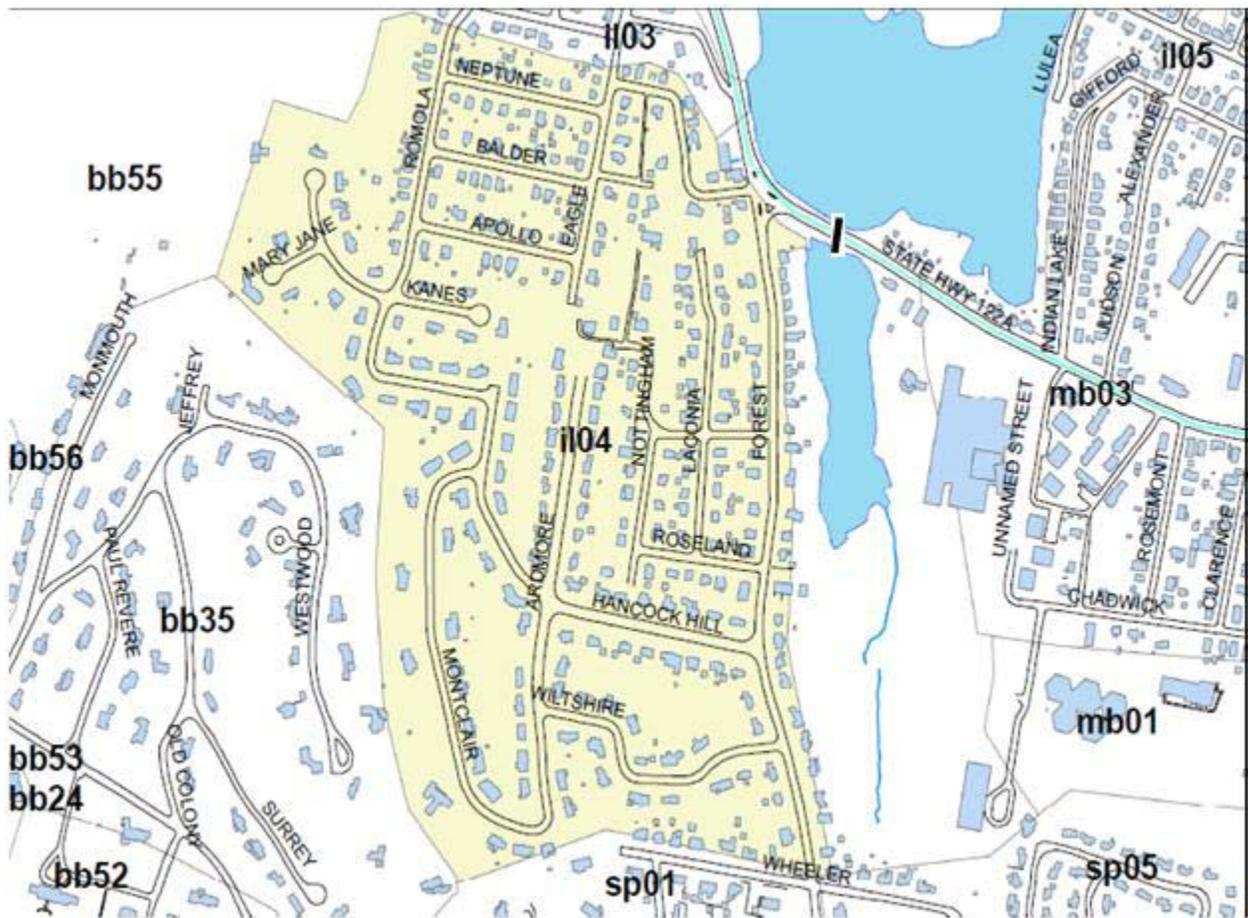
The following map, which shows the storm drains around the Little Indian Lake area and the culvert (shown as a black bar between the two bodies of water) that goes under Route MA122A that connects Indian Lake with Little Indian Lake, was obtained from Beth Proko. The biggest concern is the position and condition of the culvert that is present between the two lakes. Both the culvert and storm drains are filled with debris. Additionally, the opening to the culvert on Indian Lake is at a higher position above sea level than the opening of the culvert on Little Indian Lake. As a result of both issue, water cannot flow between Little Indian Lake and Indian Lake.

Figure 4.5: Storm Drain Map

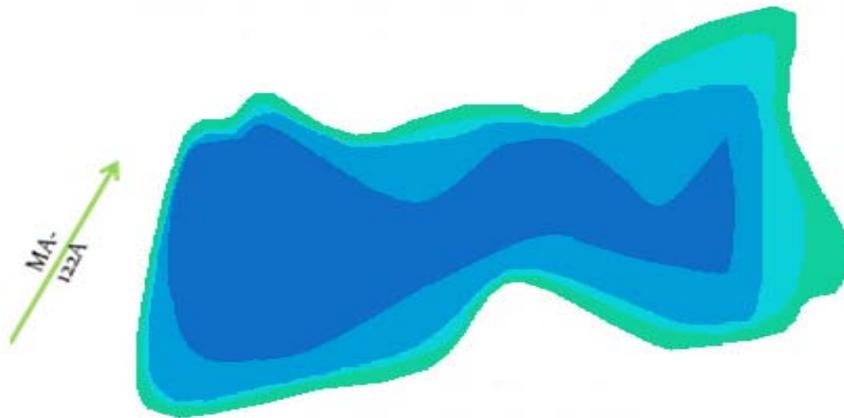
Figure 5.1: Depth Diagram from ESS Group (ESS Group, Inc. , 2006)

This comparison demonstrates that the average depth of Little Indian Lake has decreased during the past four years. Although evaporation may account for a small fraction of water loss, accumulation of sediment is primarily responsible for the decreasing depth of Little Indian Lake. The accumulation of sediment on the lake floor presents a significant long-term problem for the ILWA which, if ignored, may result in the disappearance of Little Indian Lake. One of the most effective methods of remedying the problem of accumulation on lake floors is dredging.

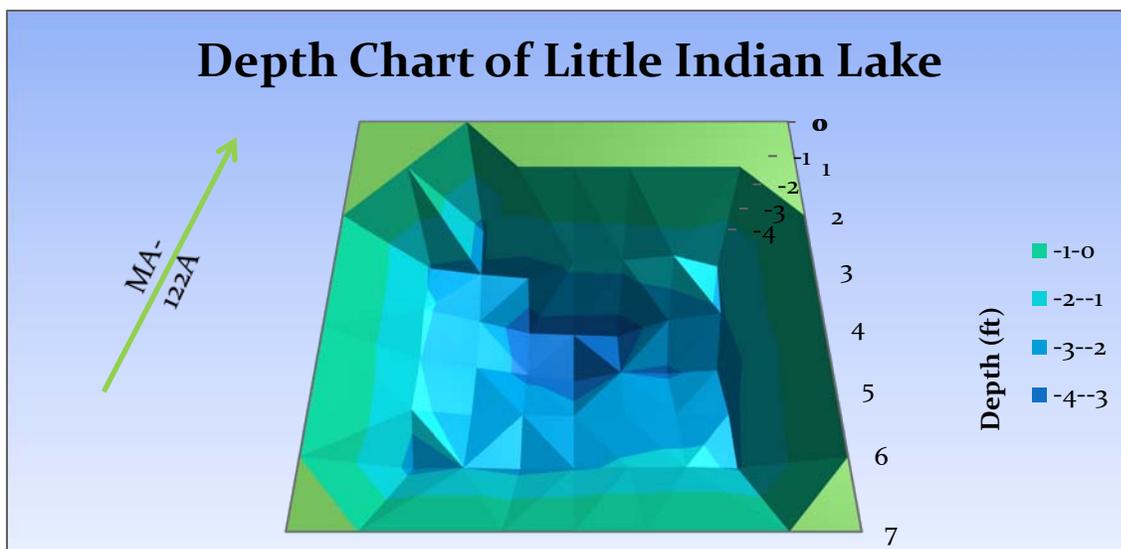
Figure 5.2: Depth Diagram (2010)

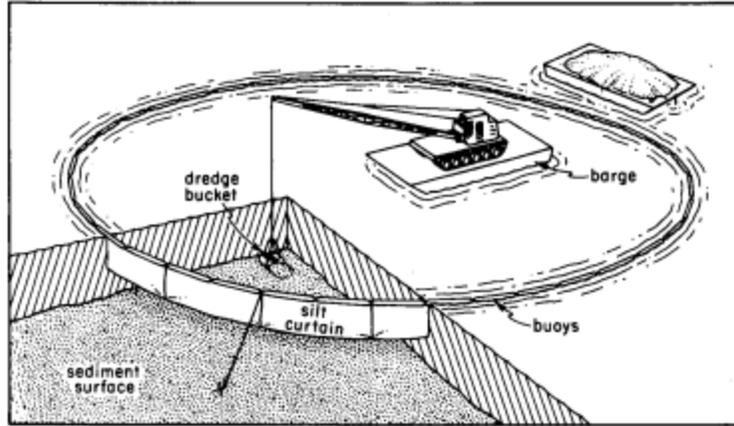
Figure 5.3: Clamshell Grab Bucket Dredge (Cooke, Welch, Peterson, & Newroth, 1986, p. 147)

The clamshell grab bucket dredge uses a floating barge to hold a crane. Then the bucket is lowered into the water to collect sediment, which it then deposits at a predetermined disposal site. Due to the small size and depth of Little Indian Lake employing this system makes little to no sense. Instead, a Sauerman grab bucket dredge would be a far superior grab bucket system. In this system the crane operates on the shoreline and drags a bucket from a certain point in the lake to the shoreline, collecting sediment along the way. Additionally, any stump or large objects, such as the toilet and large rocks encountered during our field days, would not impede the operation of the Sauerman grab bucket dredge (148).

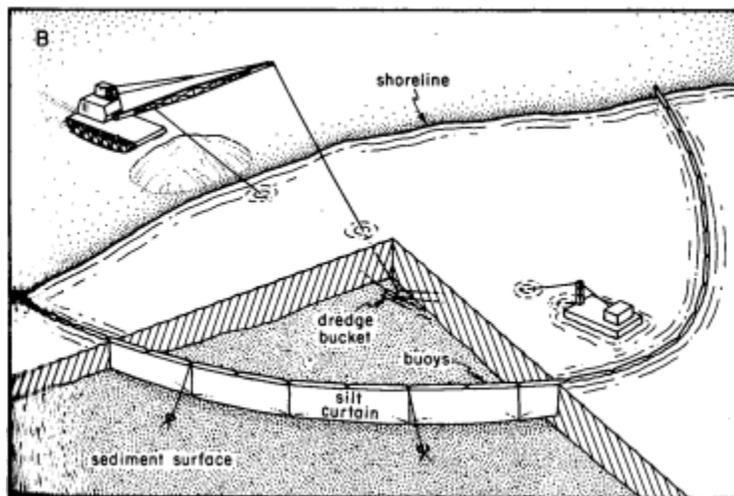
Figure 5.4: Sauerman Grab Bucket Dredge (Cooke, Welch, Peterson, & Newroth, 1986, p. 147)

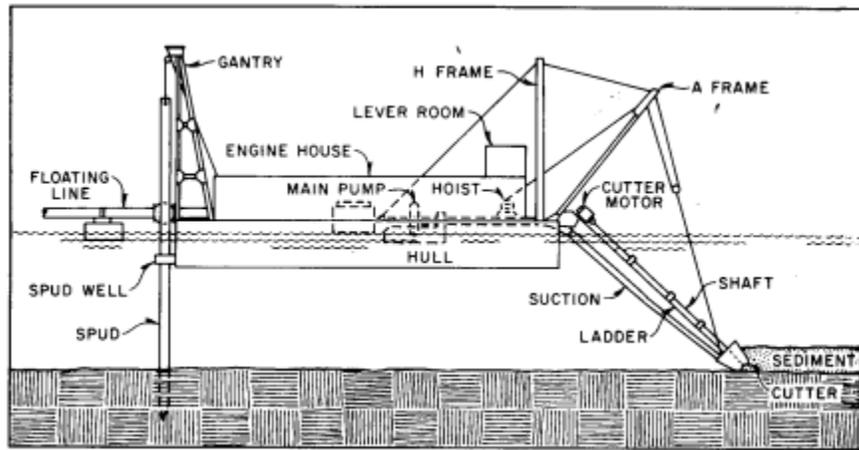
Figure 5.5: Typical Cutterhead Hydraulic Pipeline Dredge (Cooke, Welch, Peterson, & Newroth, 1986, p. 150)

Cutterhead hydraulic pipeline dredges operate by having a cutter, consisting of smooth or toothed blades, rotate to loosen sediment. The sediment is then delivered through the pipeline by creating a pressure gradient (supplied by the pump). The spuds function as the legs of the system, allowing the dredging system to "walk" around the lake by alternately raising and lowering them (149). The walking and cutting patterns which result from the alternating spuds of the system are shown below in Figure 5.6.

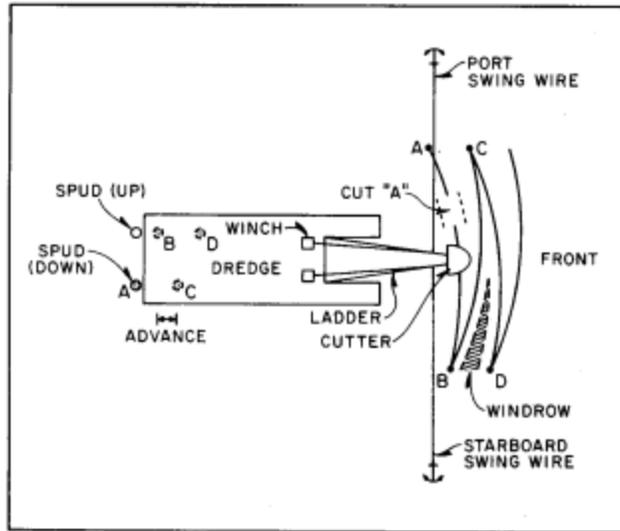
Figure 5.6: Cutterhead Dredge Walking and Cutting Pattern (Cooke, Welch, Peterson, & Newroth, 1986, p. 150)

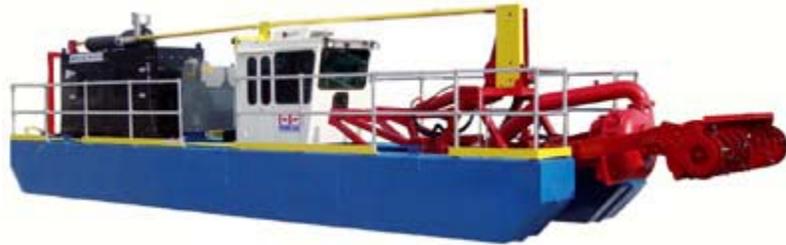
Figure 5.7: Mud Cat Dredge (Mud Cat Dredges, 2010)

Mud Cat dredges have been used with great success on small lakes. Its guidance system makes it ideal for work on small lake restoration projects. The dredge relies on a cable, anchored at both shorelines, and its guidance system to make passes on the lake floor: "The guidance system permits uniform dredging of the bottom, with few missed strips" (152). Finally, the increased water turbidity due to dredging with a Mud Cat has been shown to be within acceptable limits: "... turbidity plumes due to dredging with a Mud Cat machine were confined to an area no more than 6 m from the dredge" (151). All of these factors combine to make the Mud Cat dredge a strongly competitive choice when deciding how to dredge Little Indian Lake.

Because of size constraints, traditional cutterhead dredges are not particularly reasonable options. Instead, the Mud Cat dredge is essentially a miniature version of large cutterhead dredges. The Mud Cat boasts a horizontal auger which dislodges and transports sediment through its pipeline (151). The primary advantage of the Mud Cat is its extreme mobility, critical for the cramped shores of Little Indian Lake. Furthermore it has been shown that the Mud Cat can produce slurry with nearly double the solids content of conventional cutterhead dredges: "... the Mud Cat dredge should be capable of producing slurry containing 30-percent to 40-percent solids. This represents nearly a doubling of the solids content commonly
